Unique Waters Nomination

DAVIDSON CANYON

Unique Water Nomination
for
Davidson Canyon

Prepared by
Pima Association of Governments
Watershed Planning

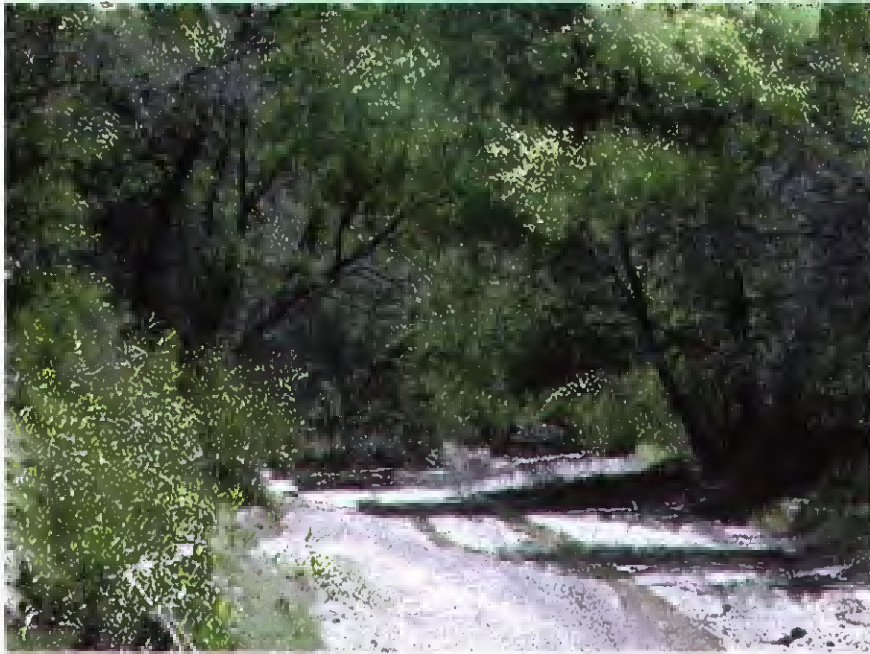
Davidson Canyon near the spring south of I-10 (looking upstream). Photograph by Gloria Browne, November 2004.

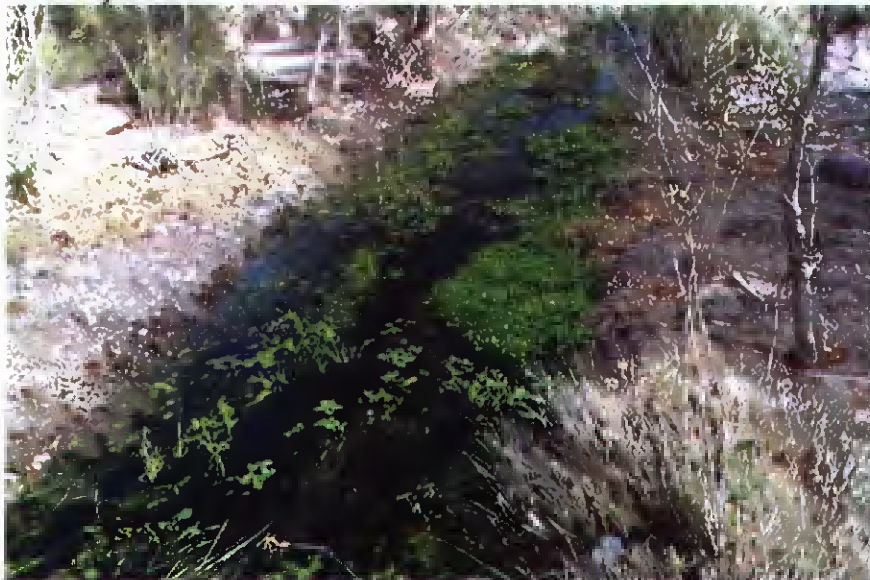
Davidson Canyon Creek, near spring south of I-10. Photograph by Linwood Smith, January 2004.

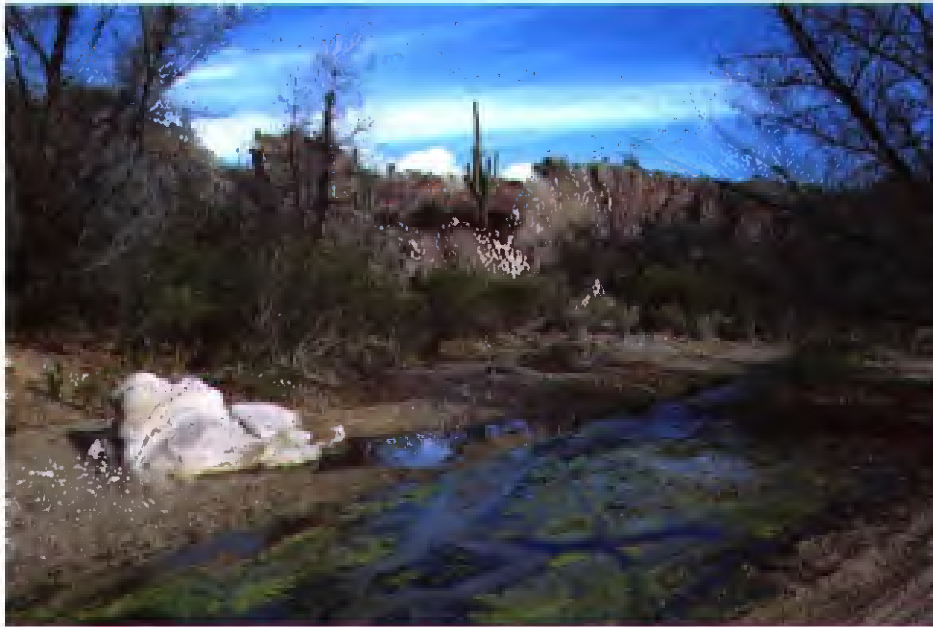
Davidson Canyon near spring south of I-10. Photograph by Linwood Smith, January 2004.

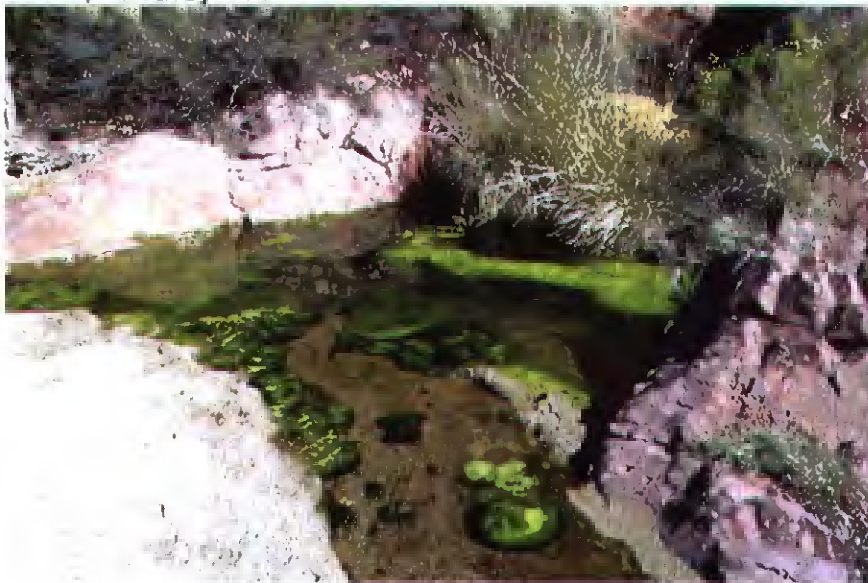
Instream pool in Davidson Canyon near spring south of I-10. Photograph by Linwood Smith, January 2004.

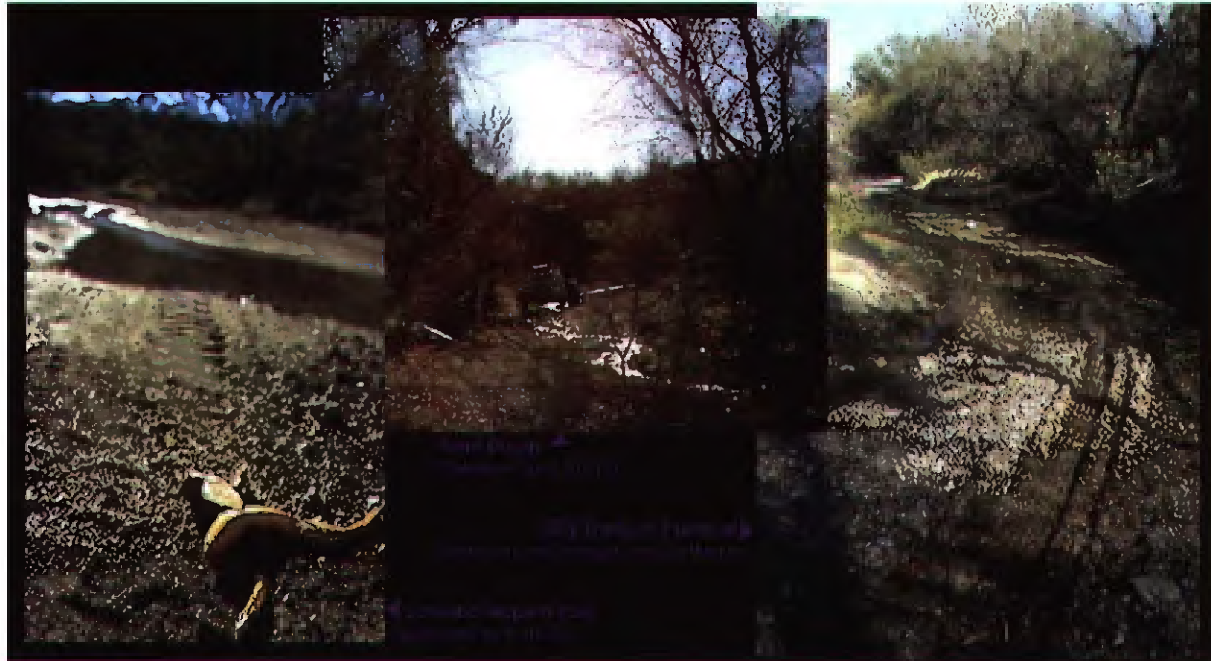
Series of photos showing streamflow and the hazards of ORV use in Davidson Canyon. Notice the dead lowland leopard frog (left). Photographs by Dennis Caldwell, February 2003.
